FAILURE ANALYSIS: DISBONDED COATING AND CATHODIC PROTECTION SHIELDING FOR PIPELINES AND UTILITY POLES

BY MEHROOZ ZAMANZADEH, MATCO SERVICES, INC. AND GEORGE T. BAYER, EXOVA

CASE 1: TRANSMISSION AND DISTRIBUTION PIPELINES

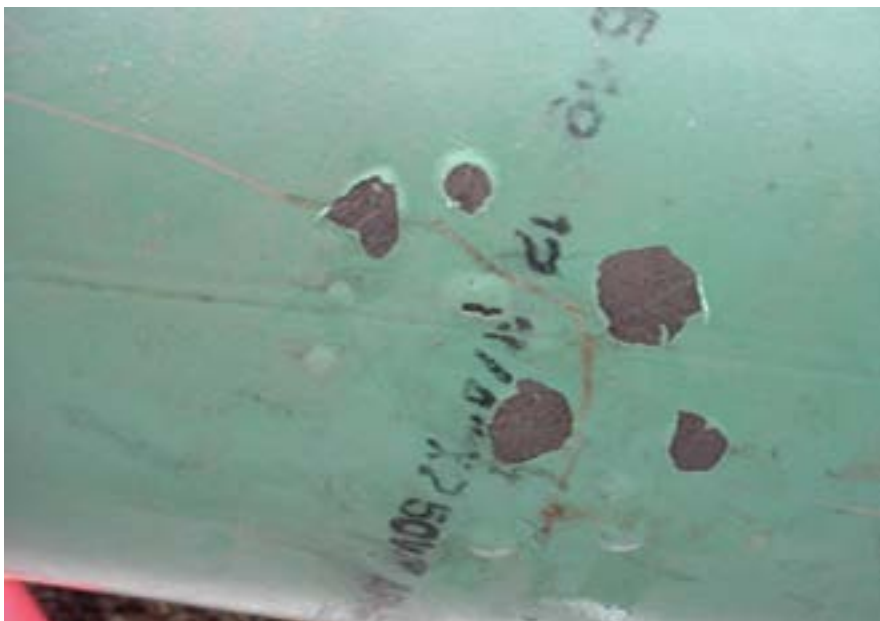
Fig. 1: Blistering of FBE coating on steel pipe. Figures courtesy of the authors unless otherwise noted.

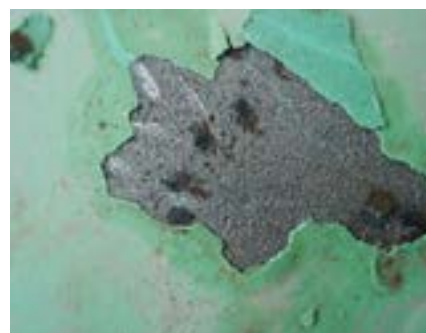
Fig. 2: Blistering of FBE coating on steel pipe.

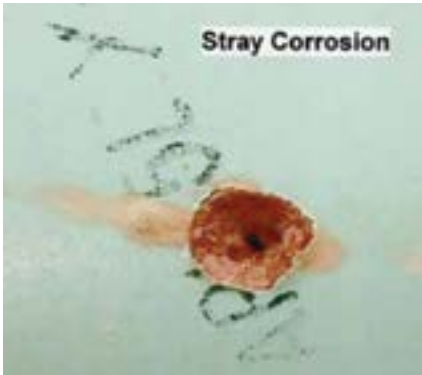
Fig. 3: Stray current corrosion of FBE coated steel pipe. This corrosion-induced failure is not related to blistering or shielding. The accelerated corrosion occurred in short time due to discharge of current at the defect holiday in the FBE coating.

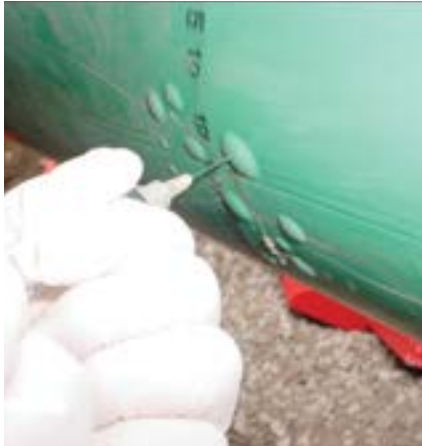
As shown in Figure 4 (p. 28), a hypodermic syringe was used to extract liquid from inside two blisters during the on-site investigation for subsequent laboratory analysis. The liquid samples were chemically analyzed to determine if they were harmful to the carbon steel pipe.

The large amounts of nitrates (614 ppm) and sodium (1.16-to-1.62 percent) were significant because they usually do not permeate through the coating readily, which means they were present prior to the application of the coating. Water and oxygen will permeate through the coating and combine with the sodium to create sodium hydroxide.

Fig. 4: Solution extraction for laboratory analysis; high alkalinity solution was present in the blister.

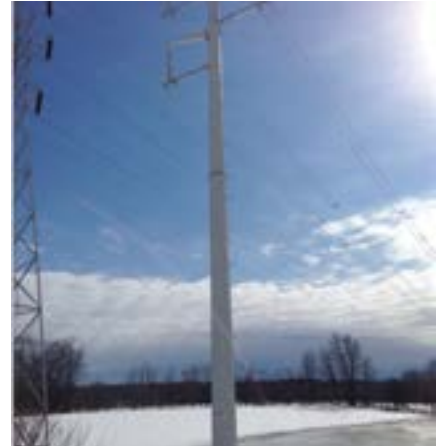
Fig. 5: A weathering steel transmission pole.

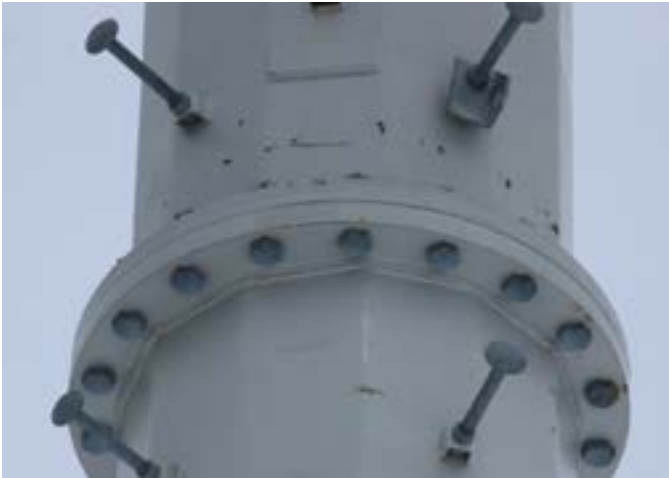
Fig. 6: Photograph showing mechanical damage to paint.

- The topcoat thickness was low on five structures and high on five structures.
- Mechanical damage to the coating was observed on all structures (Fig. 6).
- Weld splatter defects were observed on 44 structures.
- Corrosion products of weathering steel (rust) was observed on 46 structures (Fig. 7).
- Coating defects were observed on 34 structures.
- Coating repairs were observed on 3 structures.

Transportation and handling damage was evident and was manifested at locations of inadequate coating thickness. Mechanical damage from the installation process was also evident and was manifested at bolted connections due to contact by assembly tools, attachment to structure connections caused

by impact and backfill aggregate impacting the structure during the backfill process.

The client should make the pole manufacturer aware of welding and coating deficiencies found on the structures and should work to minimize transportation- and handling-induced coating damage. The client should also make the installation contractor aware of the coating damage found on the structures caused during installation and work to minimize handling- and installation-induced coating damage.

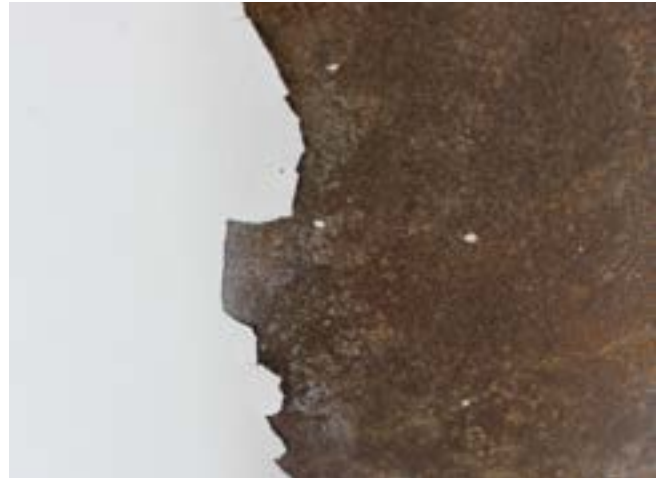
Fig. 7: Rust in area of paint delamination.

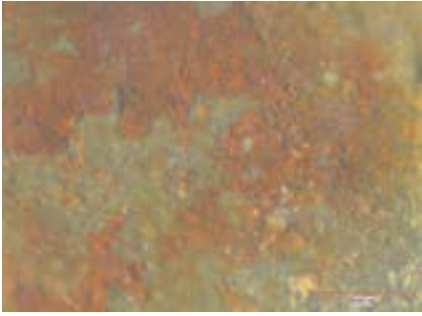
of 7 times and 45 times. At the highest magnification of 45 times, the surfaces appeared to be relatively smooth. This calls into question whether the substrate surfaces had the proper surface profile prior to primer application. The specified surface profile is 2.0-to-3.0 mils. Rust spots were apparent at selected areas of the primer/base coat surface as shown in Figure 8 (p. 33). It cannot be concluded whether this rust was present prior to coating application or appeared as a result of a breach or separation of the coating from the substrate.

Fig. 8: Photomicrograph of rust on underside of primer at 7-times magnification.

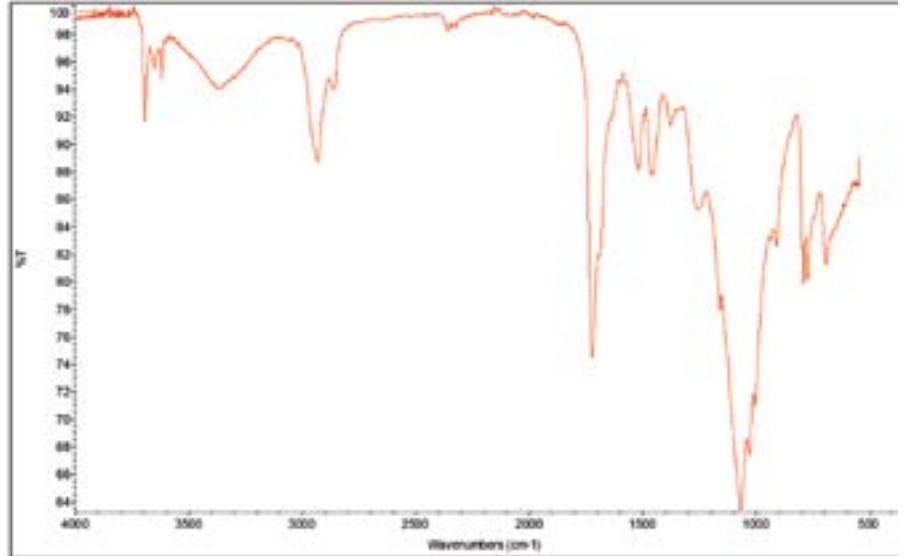
The base and topcoated sides of the five paint chip samples were subjected to FTIR analysis using a spectrometer in attenuated reflectance (ATR) mode. FTIR analysis of the base coated sides of the paint chips did not provide sufficiently distinct absorption bands for analysis. This is presumably due to the high metallic zinc loading of the base or primer coat. FTIR spectra are consistent in showing characteristic IR absorption bands attributable to aliphatic acrylic-polyester polyurethane. Figure 9 (p. 33) presents a representative FTIR spectrum of the top coating. Also, the topcoat on all five paint chip samples appeared to be of the same coating chemistry.

Fig. 9: (Right) Representative FTIR spectrum of topcoat.
